# DEALING WITH DUST INDEYANG

Tang Yong and Li Qiang, Southwest Cement Group, and Adam Feng, W. L. Gore & Associates, share how a dust collection system upgrade helped improve environmental results, reduce operating costs and increase productivity for the Lisen Cement Plant in Deyang, China.

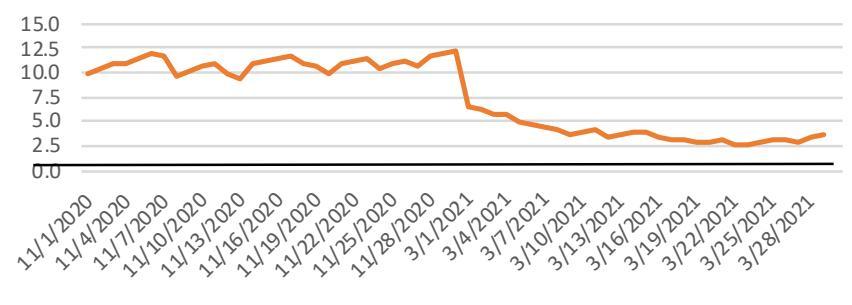
### Converted dust emissions (mg/Nm<sup>3</sup>)

- The dust emission rate is stable, and the emissions can be stabilised within 5 mg/Nm<sup>3</sup>, versus the previous range of 9~11.8 mg/Nm<sup>3</sup>.
- The power consumption of the kiln/mill filter exhaust fan has been stabilised and significantly reduced, even though clinker output (tpd) has increased by nearly 8%.

Figures 1 – 4 and Table 2 document these performance changes in the Lisen plant's dust collection system before and after the upgrades. Plot lines from 03/01/21 represent the first month of operation data after retrofitting.

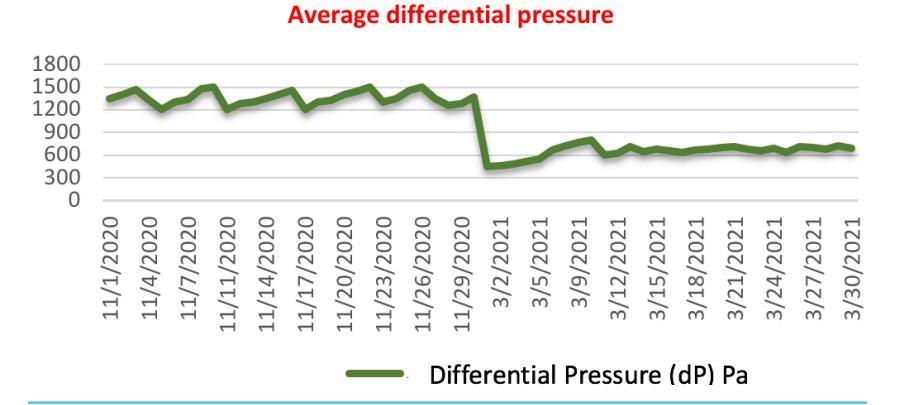
Figure 2. Comparison of differential pressure before and after upgrade.

► High system differential pressure. The plant has two raw mills at the kiln end of the production line. The differential pressure between the inlet and outlet of the dust collection system was as high as 1500 Pa with one raw mill running, and as high as 1200 Pa with both mills running. The filter fan's power consumption per ton of clinker was also relatively high.

Differential pressure of the entire dust collection system was greatly reduced. The average pressure differential at the air outlet is now only 700 Pa, versus 1200 - 1500 Pa.
