CONDENSATION REDUCTION IN SECURITY CAMERAS: COMPARATIVE PERFORMANCE OF GORE® PROTECTIVE VENTS VERSUS DESICCANTS

By Boris Pak L. Su, Zhi R. Cui and Hong Y. Yu *

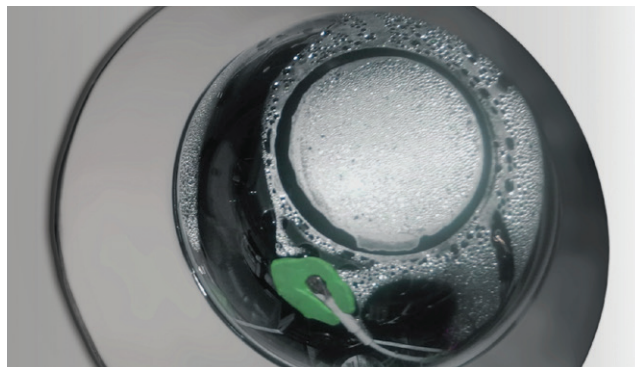
Figure 1: Desiccant could not prevent severe condensation from forming and becoming trapped within this sealed enclosure.

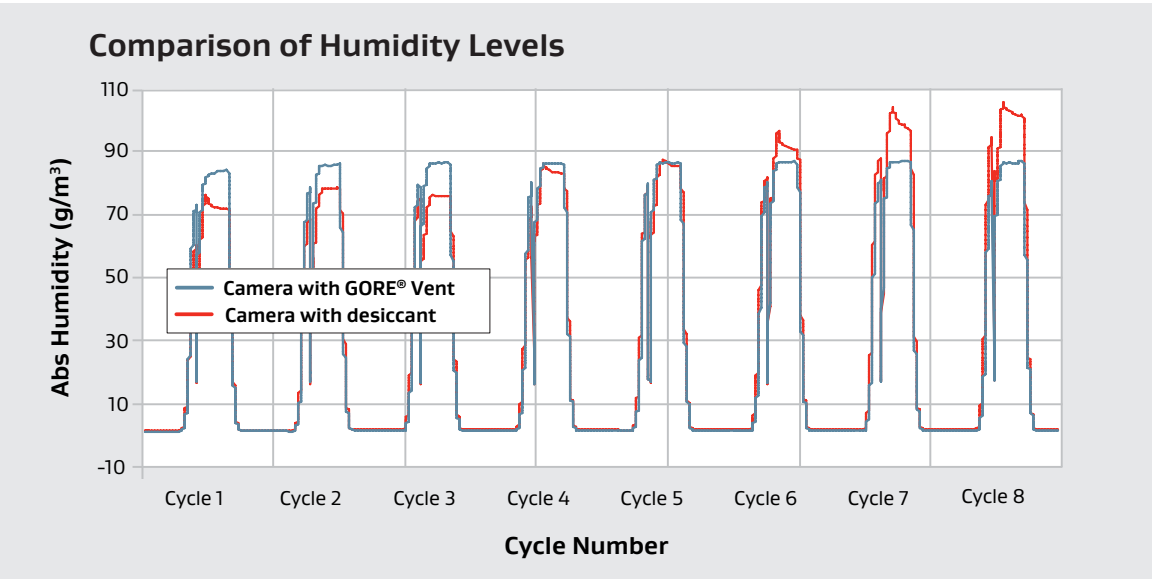
The recorded humidity levels within each camera enclosure also showed important differences. While humidity within both enclosures increased in response to climate chamber conditions, the camera with desiccant shows a significant humidity increase, beginning at Cycle 6. This is because the desiccant moisture absorption process reverses itself after several cycles of high humidity. At Cycle 6, the desiccant was fully saturated and began releasing water back into the camera enclosure, creating the condensation it was intended to combat.

Figure 6: Beginning at Cycle 6, the fully-saturated desiccant releases moisture, causing a significant increase in humidity levels within the enclosure.

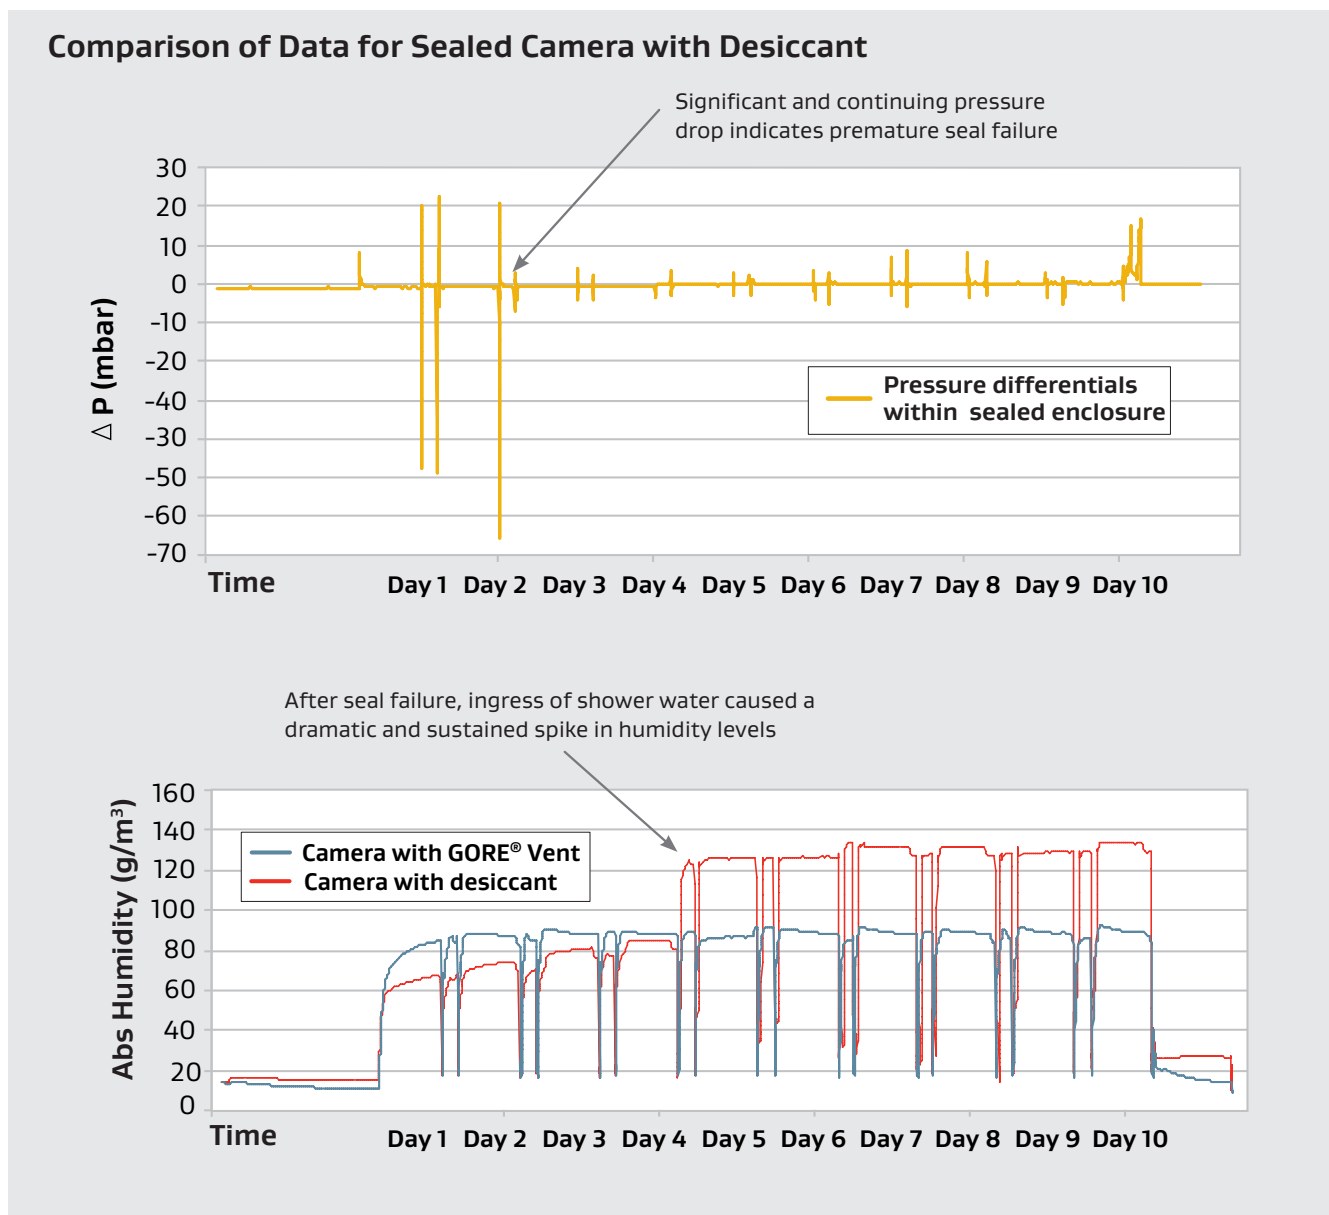
Figure 8: Because the sealed enclosure could not equalize pressure differentials, the seal was stressed to failure in just two days.

As shown in Figure 8, after Day 2, pressure differentials in the sealed camera diminished dramatically. Subsequent examination showed that the strong initial pressure differentials had stressed the seal to the point of failure.

The subsequent temperature drops (induced by the water shower) created negative pressure within the enclosure, drawing ambient air and shower water in through the failed seal. The desiccant could not counteract this trapped moisture.

Thus, excessive condensation formed on the lens, seriously degrading the image quality. In the other camera, the GORE® Vent rapidly equalized pressures, so the seal for that enclosure was not stressed to the point of failure. Since the vented enclosure's seal remained intact, there was no ingress of shower water to degrade image quality. The camera with the GORE® Vent retained consistently good image quality throughout this test.

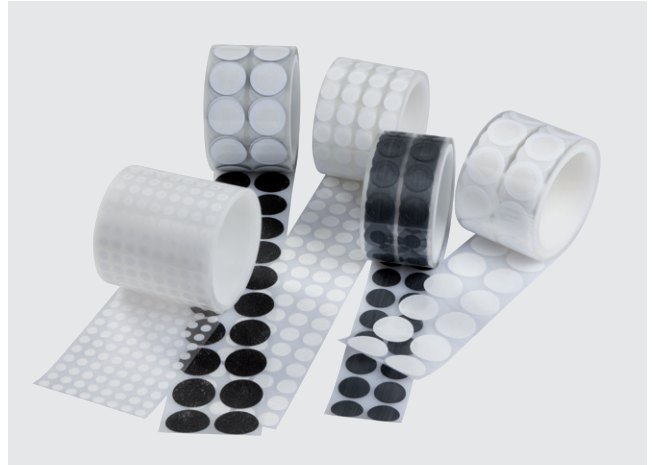
Figure 9: These flexible, low-profile vents are easily installed.
