RELIABILITY TESTING OF GORE® PROTECTIVE VENTS IN TELECOMMUNICATION ENCLOSURES

Gary Chan, Applications Engineer, Sara Ellis, Applications Engineer, Jason Zambotti, Product Development Manager

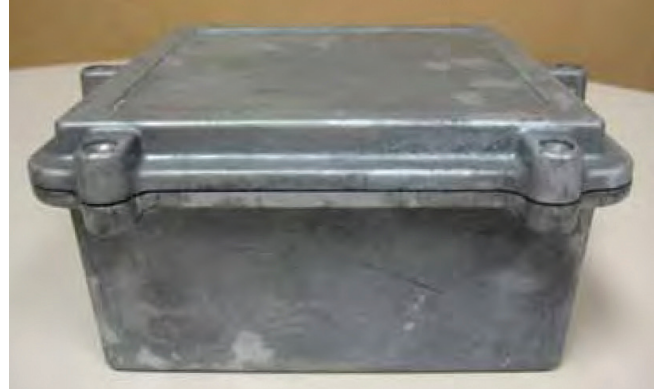
Gore purchased four commercially available outdoor housings similar to those used in the telecommunication industry. These two liter housings were constructed of aluminum with a silicone gasket, and they were rated to IP67 (Figure 1).

Figure 1: Aluminum housing used in testing

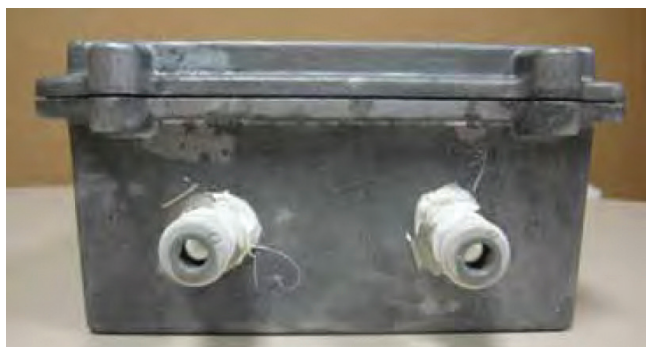
Pressure and temperature probes were installed in each enclosure (Figure 2), and an M12x1.5 Series GORE® Screw-In Vent was installed in two of the enclosures to allow pressure to equalize during the testing process (Figure 3). No electronics were installed inside the housings.

Figure 2: Aluminum housing with ports installed for pressure and temperature probes

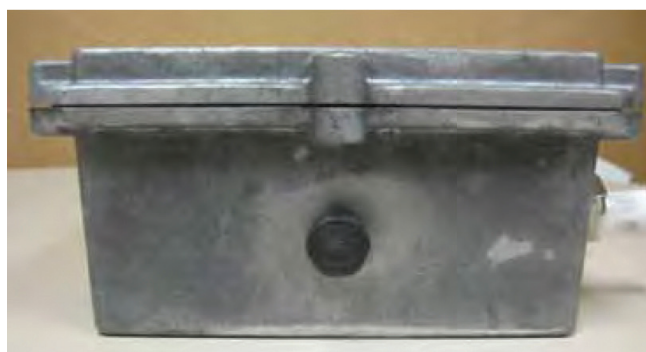
Figure 3: Aluminum housing with GORE® Protective Vent installed

The M12x1.5 GORE® Screw-In Vents installed in the two vented enclosures maintained a typical airflow of 405 milliliters/minute while providing IP67 water and particulate protection. With this level of airflow, the internal and external pressure remained equalized as the temperature changed, reducing the stress on the seals.

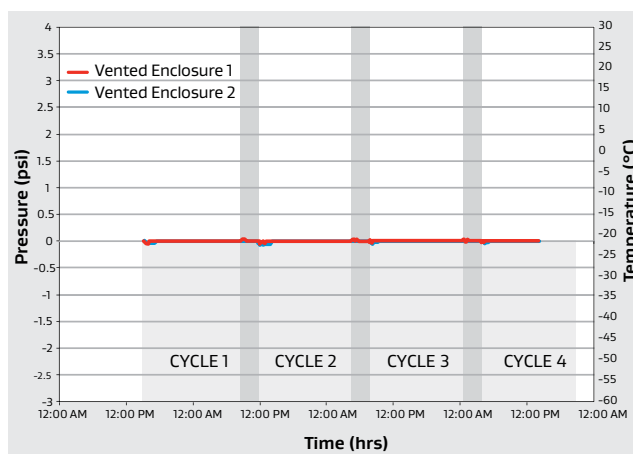
During the four cycles, the vented enclosures experienced virtually no pressure differential, and therefore they maintained the integrity of the seals during and after the testing (Figure 4).

Figure 4: Pressure differentials for vented enclosures

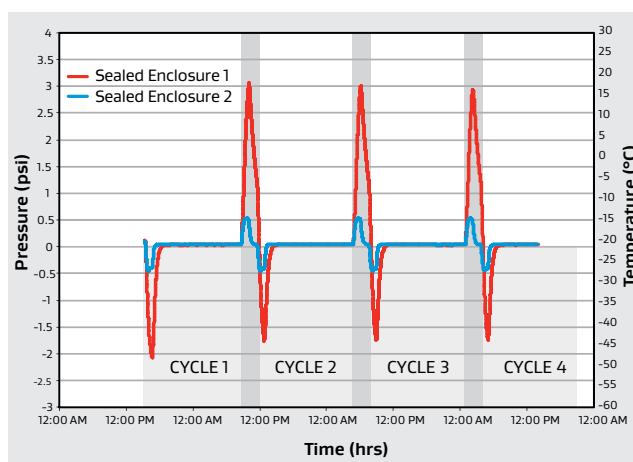
However, the pressure in the sealed enclosures changed rapidly during each cycle. These pressure differentials were caused by changes in the internal air volume as the temperature changed. As the chamber's temperature decreased, the internal air volume decreased, causing an internal vacuum. As the temperature increased, the volume of the internal air increased, putting pressure on the enclosure walls and seals.

For example, during the initial cycle at -55°C, the pressure in the first sealed enclosure exceeded -2 pounds/square inch (psi), and the pressure in the second sealed enclosure reached -0.5 psi (Figure 5).

Figure 5: Pressure differentials for sealed enclosures

Within four hours of the first -55°C cycle, the pressure inside both enclosures returned to 0 psi, which indicates that the pressure had equalized because seal integrity had been compromised. Therefore, a leak path was created. When the temperature returned to 23°C after the 16 hours at the cold temperature, the pressure inside both sealed enclosures spiked temporarily — 3 psi in the first sealed enclosure and 0.5 in the second sealed enclosure. Again, the pressure had equalized because air was able to move in and out through the leak path created in the initial cold temperature cycle.

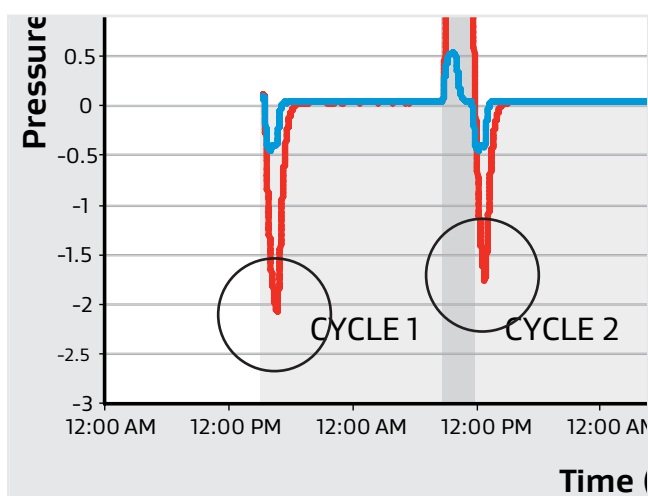
In the remaining cycles, the sealed enclosures continued to experience significant pressure differentials. However, because the seal was already compromised during the first cycle, less pressure was required before the enclosure began to draw in air through the leak path. For example, in the first cycle, the first sealed enclosure held its seal until the pressure exceeded -2 psi. In the remaining three cycles, the enclosure began to draw in air through the leak path at -1.75 psi to equalize the pressure (Figure 6).

Figure 6: Pressure differentials for first sealed enclosure

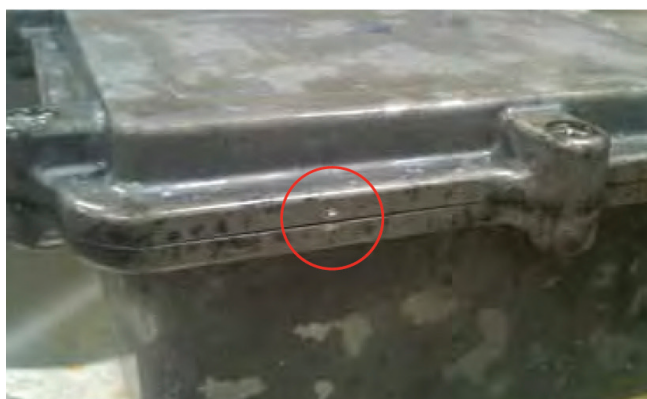
Figure 7: Enclosure visually inspected after the testing

After the testing, the Gore team followed the IEC 60068-2-1 standard protocol and visually inspected all four enclosures. They used a technique to determine potential leak paths by brushing a surfactant solution around the seals of each enclosure after the last cycle of cold temperature was completed. As the enclosures returned to ambient temperature, the internal air expanded, which would cause bubbles to form at any leak paths. For the vented enclosures, no bubbles formed. However, bubbles did form around the gaskets of the sealed enclosures (Figure 7). In addition, the team opened the enclosures and found no signs of integrity issues or long-term creep behavior with the polymer gaskets.
